**Flood Control Project Maintenance
Levee Inspections**
LMA District Cover Sheet
Spring 2018 Levee Inspection Results

Reclamation District No. 1600 Mull

Spring 2018 Levee Inspection Results

Levee Inspection Report By Mile - Spring 2018

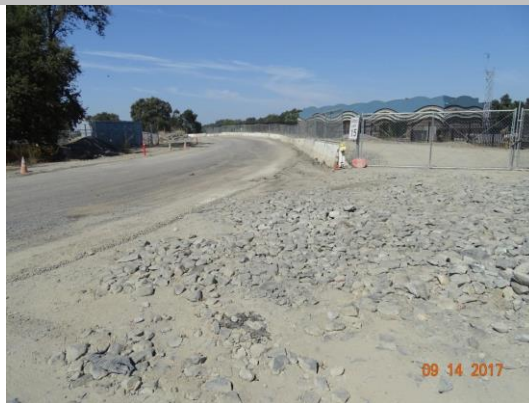
Photo 1 of 2 : SP_2018_RD1600_191_1_20180306_00001.jpg

LM Start	0.06	Rating **	A/W	Issue No.	1
LM End	0.06	Issue Type +	En	Location *	WS
Category	Earthen Levee			GPS Latitude/Longitude	
				Start	End
Item	Encroachments			38.675998 °	38.675998 °
				-121.630732 °	-121.630732 °
DWR ID	DWR_RD1600_01_s_2012_1				
Comment Code					
BU : Building					
Inspector Comment					
This is the new pumping plant for RD 2035. PN: 18763

View of new pumping plant construction. Fall 2017.

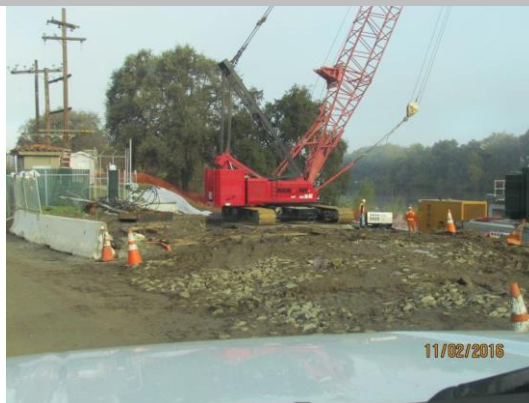
Photo 2 of 2 : SP_2018_RD1600_191_1_20180306_00002.jpg

Building was removed due to a new construction. Fall 2016.

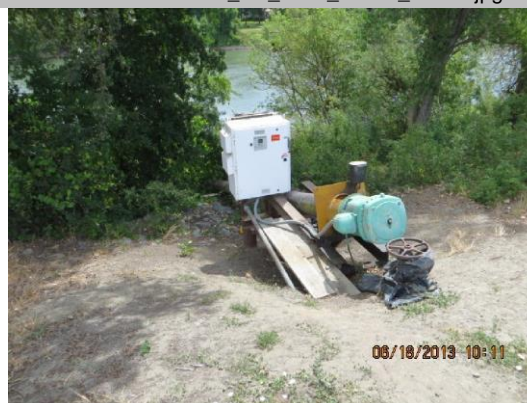
Photo 2 of 3 : UCIP_SP_2018_15285_25087.jpg

Comment Code						
Inspector Comment						
FS_ID:15285 DS_ID:21463 EP_NO: 6100 Repair Type: Non-Urgent Crossing Status: Found UCIP Comments: Gate valve will not open or close. FIELD_STRUCT_DESC: 12-inch steel irrigation pipe through the levee, 3.4 feet below the crown. Slant pump and gate valve on the waterside (WS) slope. Siphon breaker in a 12-inch steel riser on the landside (LS) shoulder. Filter, booster pump, and butterfly valve on the LS toe. 2.25-inch galvanized iron electrical conduit at the same location. (Permit No. 6100, 1968 - Charles Plumb Jr., replaced 8-inch pipe at same location). [Additional Reference(s): DWR Levee Log, 1988]. FS Date: 6/18/2013

Pump and gate valve on WS slope.

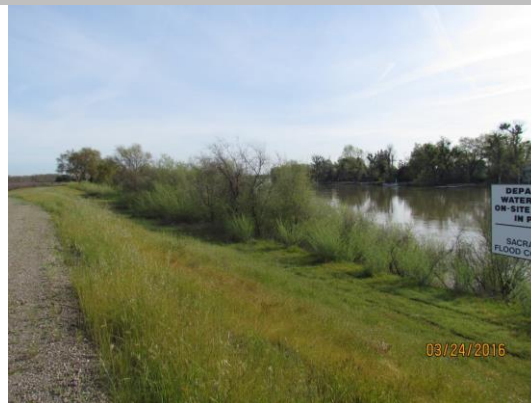
Photo 1 of 2 : SP_2018_RD1600_191_5_20180306_00006.jpg

LM Start	1.40	Rating **	A/W	Issue No.	5
LM End	1.40	Issue Type +	Ob	Location *	WS
Category	Earthen Levee			GPS Latitude/Longitude	
				Start	End
Item	Vegetation			38.694469 °	38.694469 °
				-121.634312 °	-121.634312 °
DWR ID	DWR_RD1600_01_f_2012_5				
Comment Code					
V8 : Environmental Requirements.					
Inspector Comment

View of the revegetation site on the berm of the waterward side of the levee looking upstream. Spring 2016.

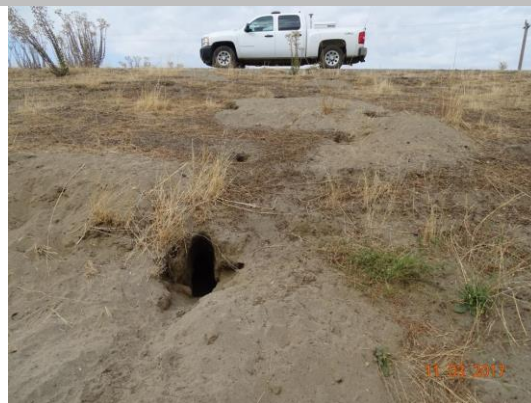
Photo 1 of 1 : SP_2018_RD1600_191_62_20180306_00048.jpg

LM Start	2.03	Rating **	U	Issue No.	62
LM End	2.03	Issue Type +	Ma	Location *	WS
Category	Earthen Levee			GPS Latitude/Longitude	
				Start	End
Item	Animal Control			38.701780 °	38.701780 °
				-121.627648 °	-121.627648 °
DWR ID	DWR_RD1600_01_f_2017_62				
Comment Code					
A3 : No rodents visible, but rodent burrows visible; need to backfill and compact or grout burrows.					
Inspector Comment					
Multiple large holes over 1' wide on waterside slope.

View of rodent holes on waterside slope. Fall 2017.

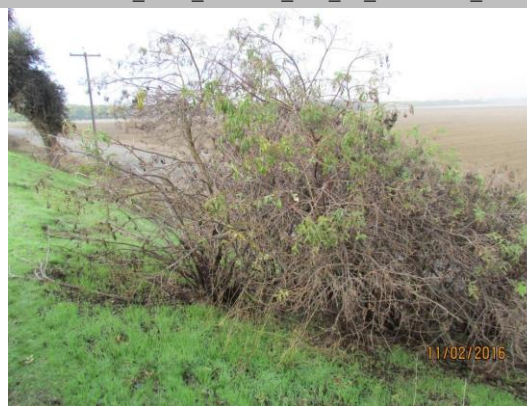
Photo 1 of 1 : SP_2018_RD1600_191_45_20180306_00039.jpg

LM Start	2.61	Rating **	A/W	Issue No.	45
LM End	2.61	Issue Type +	Ma	Location *	LS
Category	Earthen Levee			GPS Latitude/Longitude	
				Start	End
Item	Vegetation			38.707311 °	38.707311 °
				-121.619517 °	-121.619517 °
DWR ID	DWR_RD1600_01_f_2016_45				
Comment Code					
V4 : Elderberries are blocking visibility and flood fight capability.					
Inspector Comment

Elderberry tree on landside slope. Fall 2016.

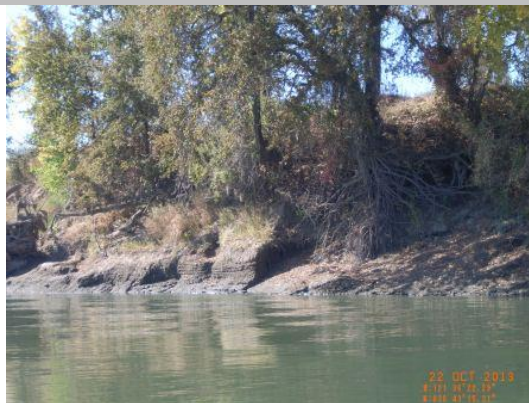
Photo 1 of 1 : SP_2018_RD1600_191_3_20180306_00003.jpg

LM Start	3.58	Rating **	M	Issue No.	3
LM End	3.83	Issue Type +	Ma	Location *	WS
Category	Supplemental			GPS Latitude/Longitude	
				Start	End
Item	2015 USACE Erosion Survey, DRAFT			38.717770 °	38.721351 °
				-121.607423 °	-121.606414 °
DWR ID	DWR_RD1600_01_s_2016_3				
Comment Code					
Inspector Comment					
1997 - Steep high bank. 2005 - Some small pockets in the low toe near the waterline. 2006 - Minor slope clearing. 2010 - Minor new erosion. 2011 - Multiple trees have fallen since last year. Some other trees look ready to fall. Significant new erosion since last year. 2012 - Minor new erosion. 2013 - Minor new erosion. 2015: New minor erosion at toe. [2015 Site ID: SAC 74-4 R]

USACE 2013 Photo #1

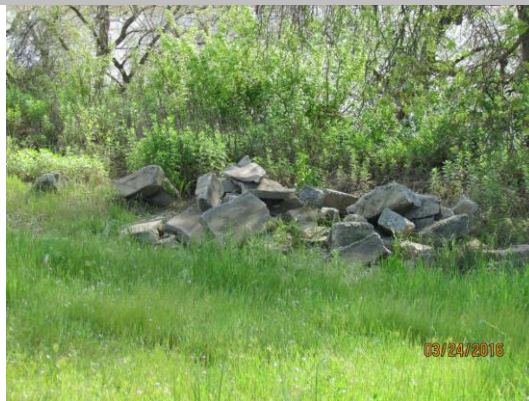
Photo 1 of 2 : SP_2018_RD1600_191_628_20180306_00071.jpg

LM Start	3.59	Rating **	M	Issue No.	628
LM End	3.59	Issue Type +	En	Location *	WS
Category	Earthen Levee			GPS Latitude/Longitude	
				Start	End
Item	Encroachments			38.718080 °	38.718080 °
				-121.607815 °	-121.607815 °
DWR ID	DWR_RD1600_01_s_2014_628				
Comment Code					
DE : Debris					
Inspector Comment

View of the concrete pile on the berm of the waterward side of the levee. Spring 2016.

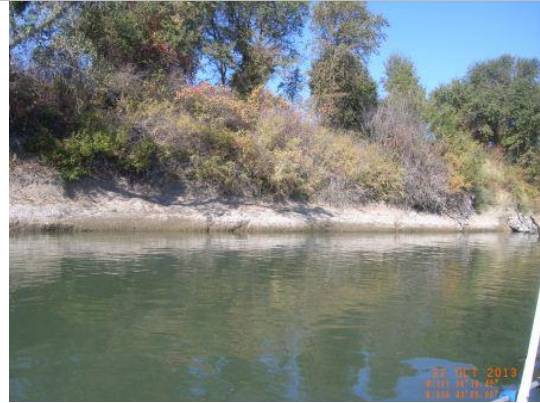
Photo 1 of 1 : SP_2018_RD1600_191_8_20180306_00010.jpg

LM Start	4.34	Rating **	M	Issue No.	8
LM End	4.86	Issue Type +	Ma	Location *	WS
Category	Supplemental			GPS Latitude/Longitude	
				Start	End
Item	2015 USACE Erosion Survey, DRAFT			38.728684 °	38.736110 °
				-121.605844 °	-121.604153 °
DWR ID	DWR_RD1600_01_s_2016_8				
Comment Code					
Inspector Comment					
1997 - Very steep bank. 2005 - Lots of small trees down along the bank at the upstream end. 2006 - Minor new erosion, but slow. 2010 - Almost all of the roots are exposed on the trees, appears ready to fall. 2011 - New erosion and tree popouts. 2012 - Site has become overgrown with vegetation, making it hard to observe. 2015: Dense vegetation made observation difficult. [2015 Site ID: SAC_75-3_R]

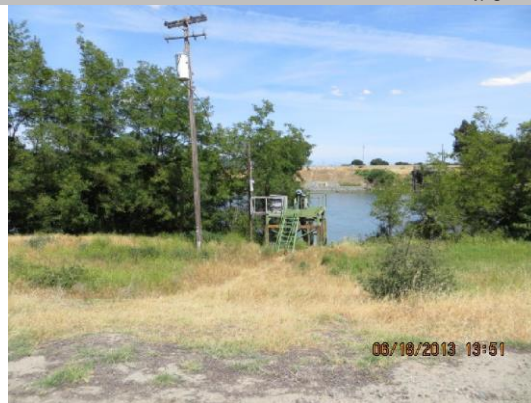
Photo 2 of 3 : UCIP_SP_2018_15125_24845.jpg

Slant pump on metal pier on WS berm.

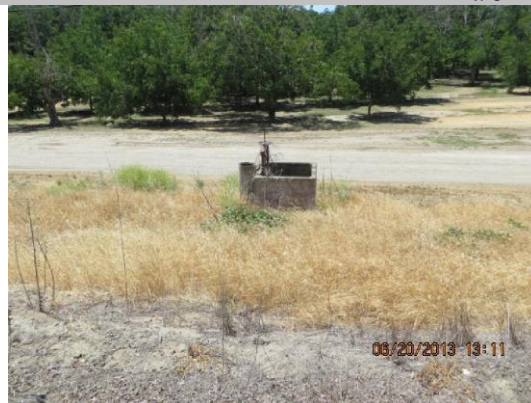
Photo 1 of 3 : UCIP_SP_2018_50101_25011.jpg

6'X6' concrete distribution box on LS toe.

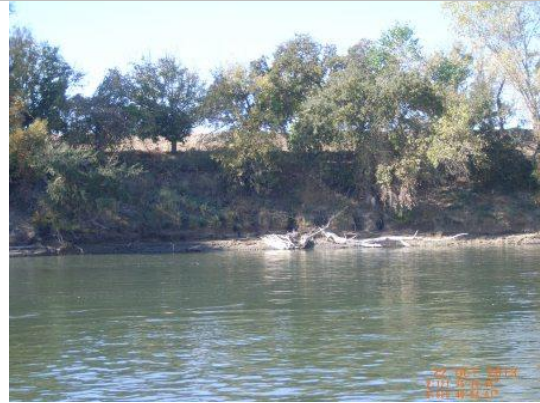
Photo 1 of 1 : SP_2018_RD1600_191_6_20180306_00008.jpg

LM Start	6.95	Rating **	M	Issue No.	6
LM End	6.98	Issue Type +	Ma	Location *	WS
Category	Supplemental			GPS Latitude/Longitude	
				Start	End
Item	2015 USACE Erosion Survey, DRAFT			38.764801 °	38.765219 °
				-121.594926 °	-121.595049 °
DWR ID	DWR_RD1600_01_s_2016_6				
Comment Code					
Inspector Comment					
2006 - Eddy scour off end of rock causing erosion and scour hole near levee. Sandy silt bank with rock on upstream end. 2010 - Trees are leaning more, minor new erosion. 2011 - Many of the tree roots have scoured out and trees look ready to fall. 2015: No observed changes. [2015 Site ID: SAC 77-7 R]

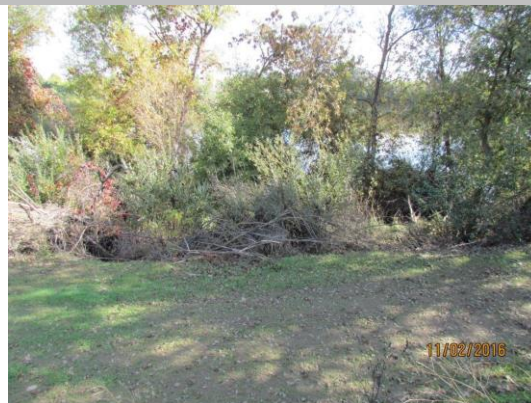
Photo 5 of 5 : SP_2018_RD1600_191_20_20180306_00017.jpg

LM Start	7.10	Rating **	A/W	Issue No.	20 (cont)	
LM End	7.10	Issue Type +	Ma	Location *	WS	
Category	Earthen Levee			GPS Latitude/Longitude		
				Start		End
Item	Erosion / Bank Caving			38.766691 °		38.766691 °
				-121.596300 °		-121.596300 °
DWR ID	DWR_RD1600_01_s_2012_20					
Comment Code						
E1 : Note and monitor erosion site.						
Inspector Comment						
Erosion present at the berm, and it hasn't got into the levee prism yet.

Updated view of erosion site. Fall 2016.

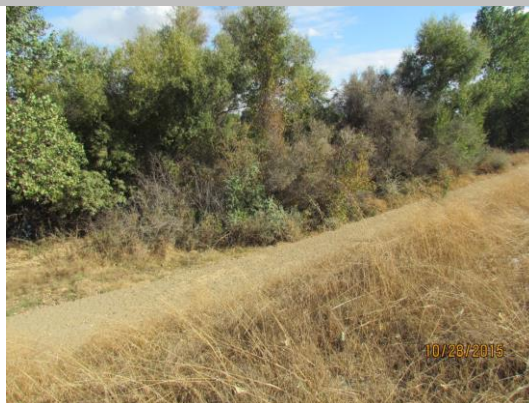
Photo 3 of 3 : SP_2018_RD1600_191_21_20180306_00020.jpg

View of the erosion along the waterward berm of the levee. Fall 2015.

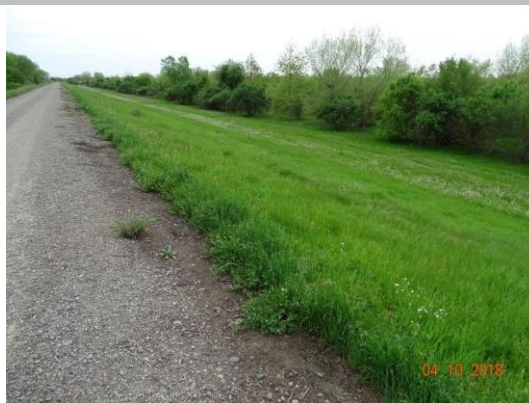
Photo 1 of 1 : SP_2018_RD1600_191_38_20180413_00097.jpg

LM Start	8.51	Rating **	M	Issue No.	38
LM End	10.35	Issue Type +	Ma	Location *	LS
Category	Earthen Levee			GPS Latitude/Longitude	
				Start	End
Item	Vegetation			38.780299 °	38.766638 °
				-121.613904 °	-121.634023 °
DWR ID	DWR_RD1600_01_s_2018_38				
Comment Code					
V1 : Control annual grass and weeds on the levee slopes and easements.					
Inspector Comment

View of vegetation on the landside slope. Spring 2018.

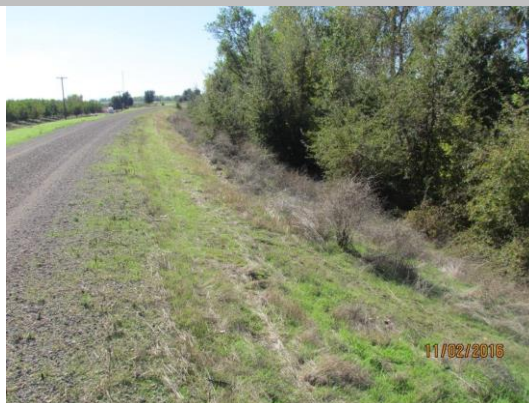
Photo 1 of 1 : SP_2018_RD1600_191_66_20180306_00050.jpg

LM Start	9.40	Rating **	M	Issue No.	66
LM End	10.45	Issue Type +	Ma	Location *	WS
Category	Earthen Levee			GPS Latitude/Longitude	
				Start	End
Item	Vegetation			38.778649 °	38.765406 °
				-121.627172 °	-121.635004 °
DWR ID	DWR_RD1600_01_f_2016_66				
Comment Code					
V2 : Remove the wild growth other than native grasses from the levee slopes.					
Inspector Comment

Vegetation on WS slope has been cleared only about 10 ft. from the crown. Fall 2016.

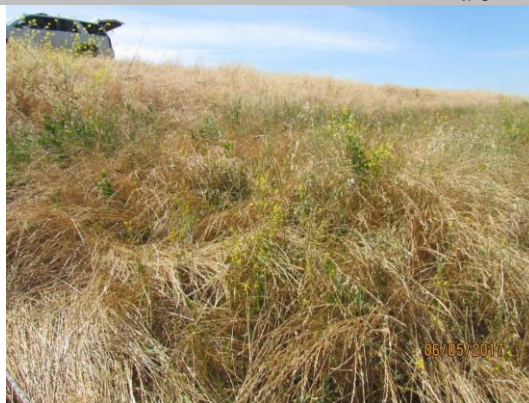
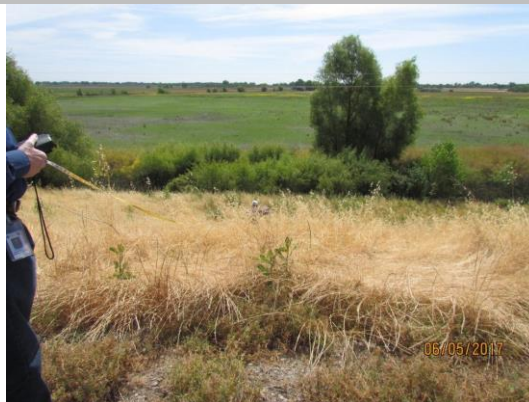
LM Start	0.20	Rating **	A/W	Issue No.	17 (cont)	
LM End	4.21	Issue Type +	Ma	Location *		
Category	Supplemental			GPS Latitude/Longitude		
				Start	End	
Item	2017 Storm Damage			38.733333 °	38.676750 °	
				-121.633611 °	-121.643250 °	
DWR ID	DWR_RD1600_02_f_2017_17					
Comment Code						
Inspector Comment						
Levee Evaluation Comments						
Description:						
Site ID No:202						
Site Designation:RD 1600-01						
Repair Type: Erosion						
Rating:Area of Concern						
Field Date:6/5/2017						
Notes: dense vegetation makes identification difficult

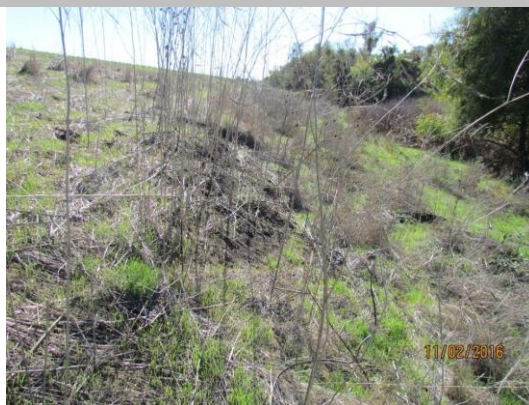
Photo 4 of 4 : SP_2018_RD1600_192_14_20180306_00010.jpg

Updated view of erosion site on WS slope. Fall 2016.

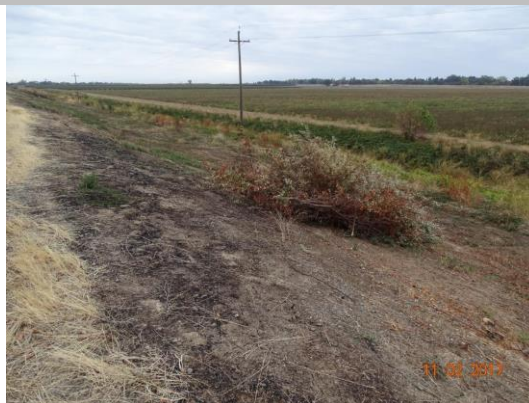
Photo 1 of 1 : SP_2018_RD1600_192_25_20180306_00020.jpg

LM Start	4.00	Rating **	M	Issue No.	25
LM End	4.00	Issue Type +	Ma	Location *	LS
Category	Earthen Levee			GPS Latitude/Longitude	
				Start	End
Item	Encroachments			38.679714 °	38.679714 °
				-121.644035 °	-121.644035 °
DWR ID	DWR_RD1600_02_f_2017_25				
Comment Code					
PR : Prunings					
Inspector Comment					
Prunings on landside slope.

View of pruning pile on landside slope. Fall 2017.
